Manhole Inspection Summary

Manhole # S15GG_006MH

Location Address: **UNDER RR TRACKS**

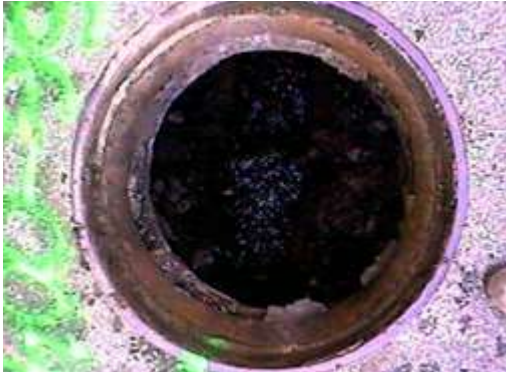
Defect 2

Condition: ☐ Sound ☒ **Cracked** ☐ Root Intrusion ☒ **Loose Brick** ☐ Deteriorated

Loose bricks and cracked chimney

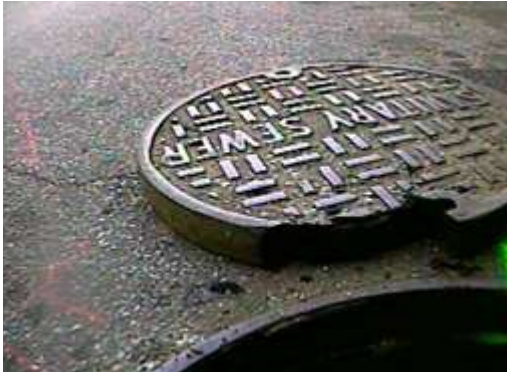
Defect 1

Comments **BROKEN LID WITH HOLE**

Type: **Sanitary** Condition: **Broken** Cover Material: **Cast Iron**

BROKEN LID

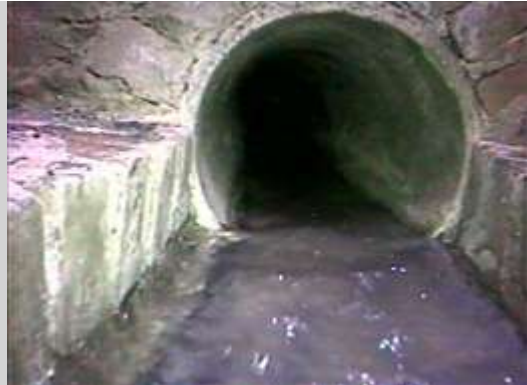
12 O'Clock Outflow

Pipe Height: (in.) Direct
Pipe Material: **Clay** ☐ Pipe Lined
Invert Depth: **4.27** (ft.) Flow Characteristics: **Fast**
Deposits: ☐ None ☐ Mud ☐ Sludge ☒ **Debris** ☐ Grease
Silt Depth: **1** (in.) Deposits Extent: **Light**
Infiltration: **None** Pipe Seal Cond: **Sound**

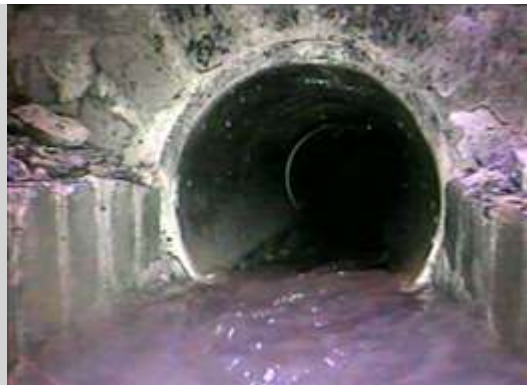
6 O'Clock Inflow

Pipe Height: (in.) Direct
Pipe Material: **Clay** ☐ Pipe Lined
Invert Depth: **4.30** (ft.) Flow Characteristics: **Fast**
Deposits: ☐ None ☐ Mud ☐ Sludge ☒ **Debris** ☐ Grease
Silt Depth: **1** (in.) Deposits Extent: **Light**
Infiltration: **None** Pipe Seal Cond: **Sound**
